Navajo Abandoned Uranium Mine

Site Screen Report

Silentman 1 AUM Site

August 2010

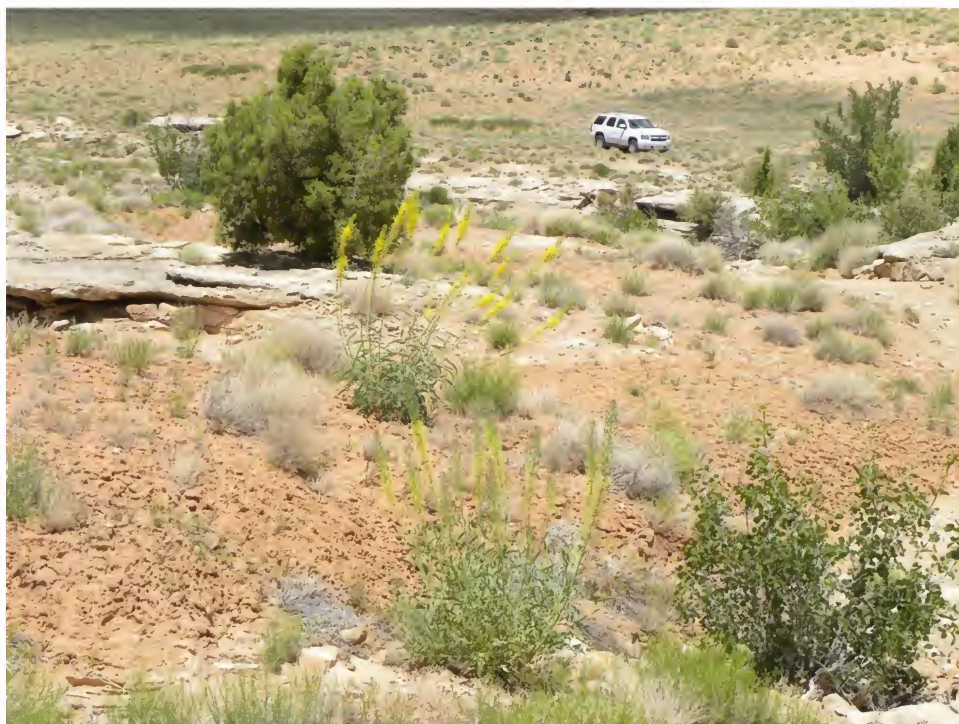
2 reclamation caps: 50' x 20' x 2'; 15' x 10' x 0.5'

Is the cap/seal functionally intact? Yes

Is the cap/seal sufficiently degraded to create a concern about releases? No

Photo 2. Silentman 1 site, reclamation cap

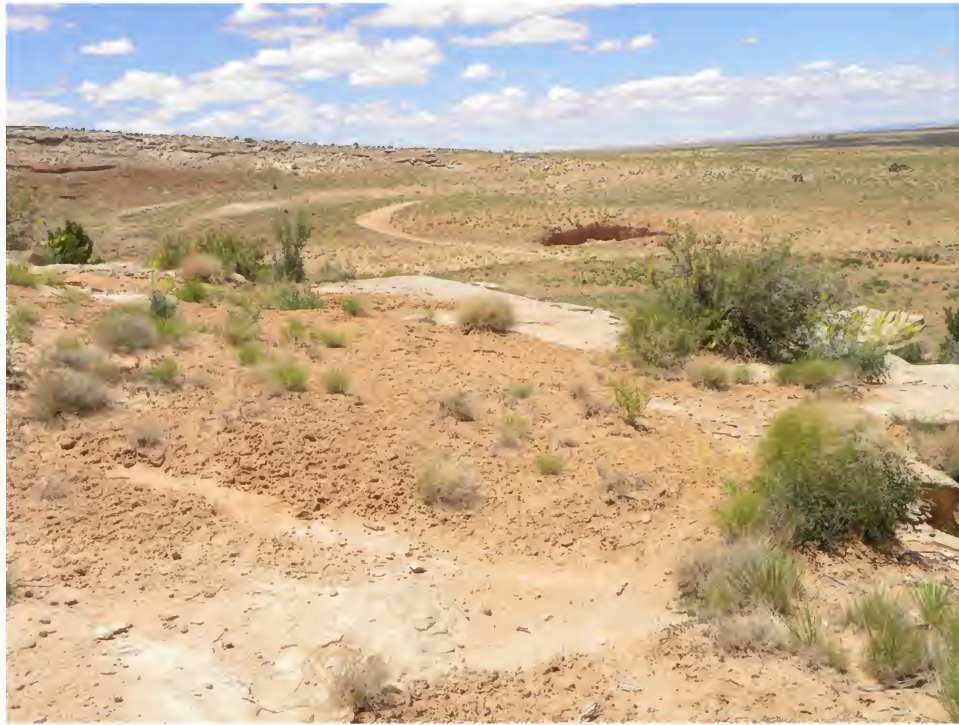
Photo 3. Silentman 1 site, reclamation cap

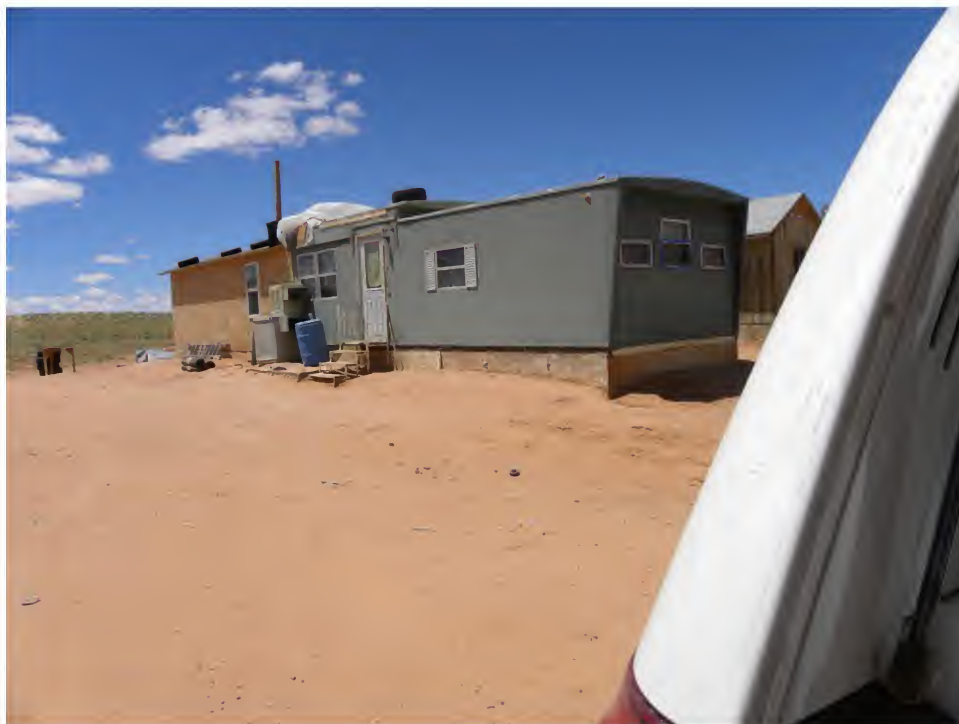
200 feet to 0.25 mile: Growler residence approximately 700 ft NW of site

Consistent with background levels

Photo 4. Silentman 1 site, Growler residence NW of site

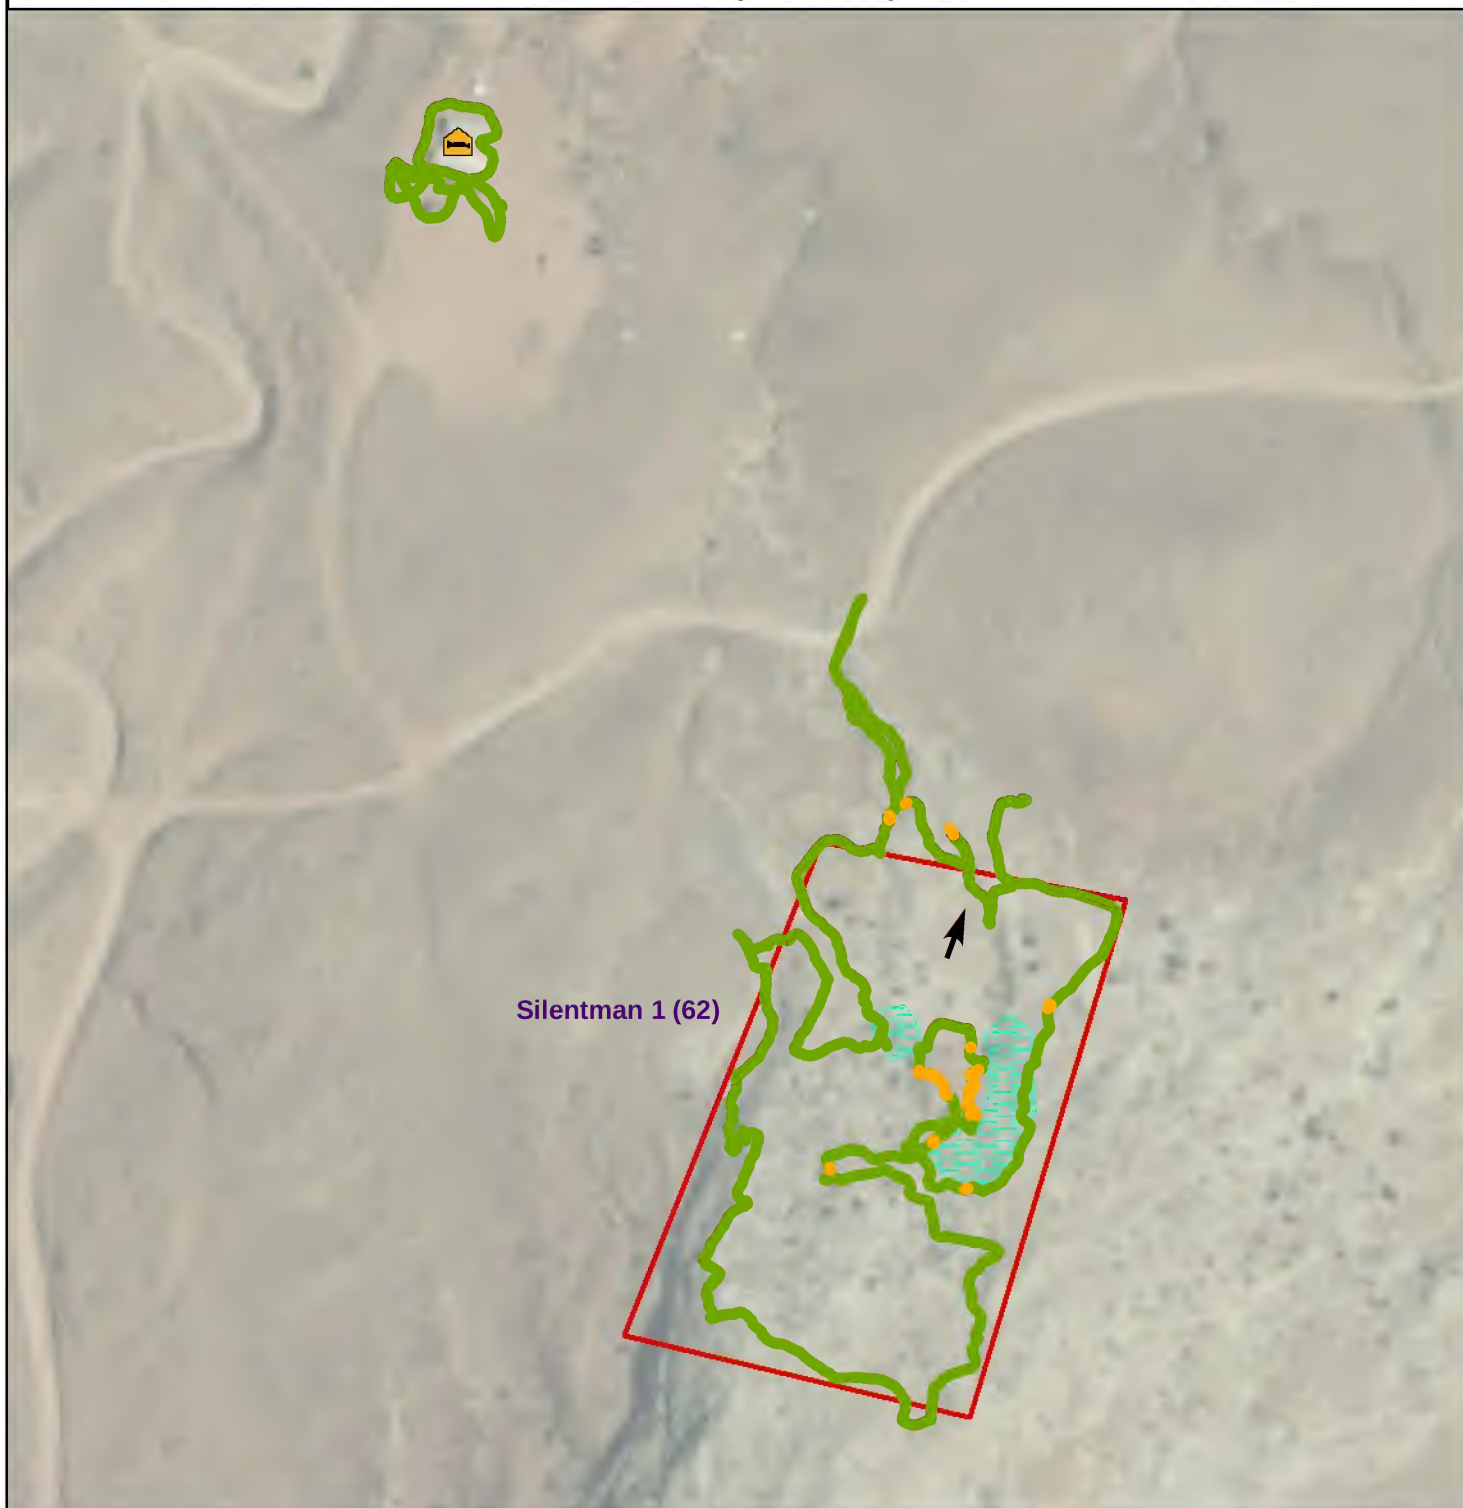
**Figure 1 - Gamma Radiation Measurements, Above Two Times Background
 Silentman 1 (62)
 Teec Nos Pos Chapter, Navajo Nation**

A total of 1,804 gamma radiation measurements were collected from the mine site, ranging from 5,095 cpm to 61,501 cpm. Measurements collected in the vicinity of the reclamation caps were found at levels ranging from approximately 20,000 cpm to 60,000 cpm. The measurements are represented in Figures 1 and 2.

Gamma survey conducted 06/2010
 Measured as counts per minute (cpm)

Average background = 11,042 cpm

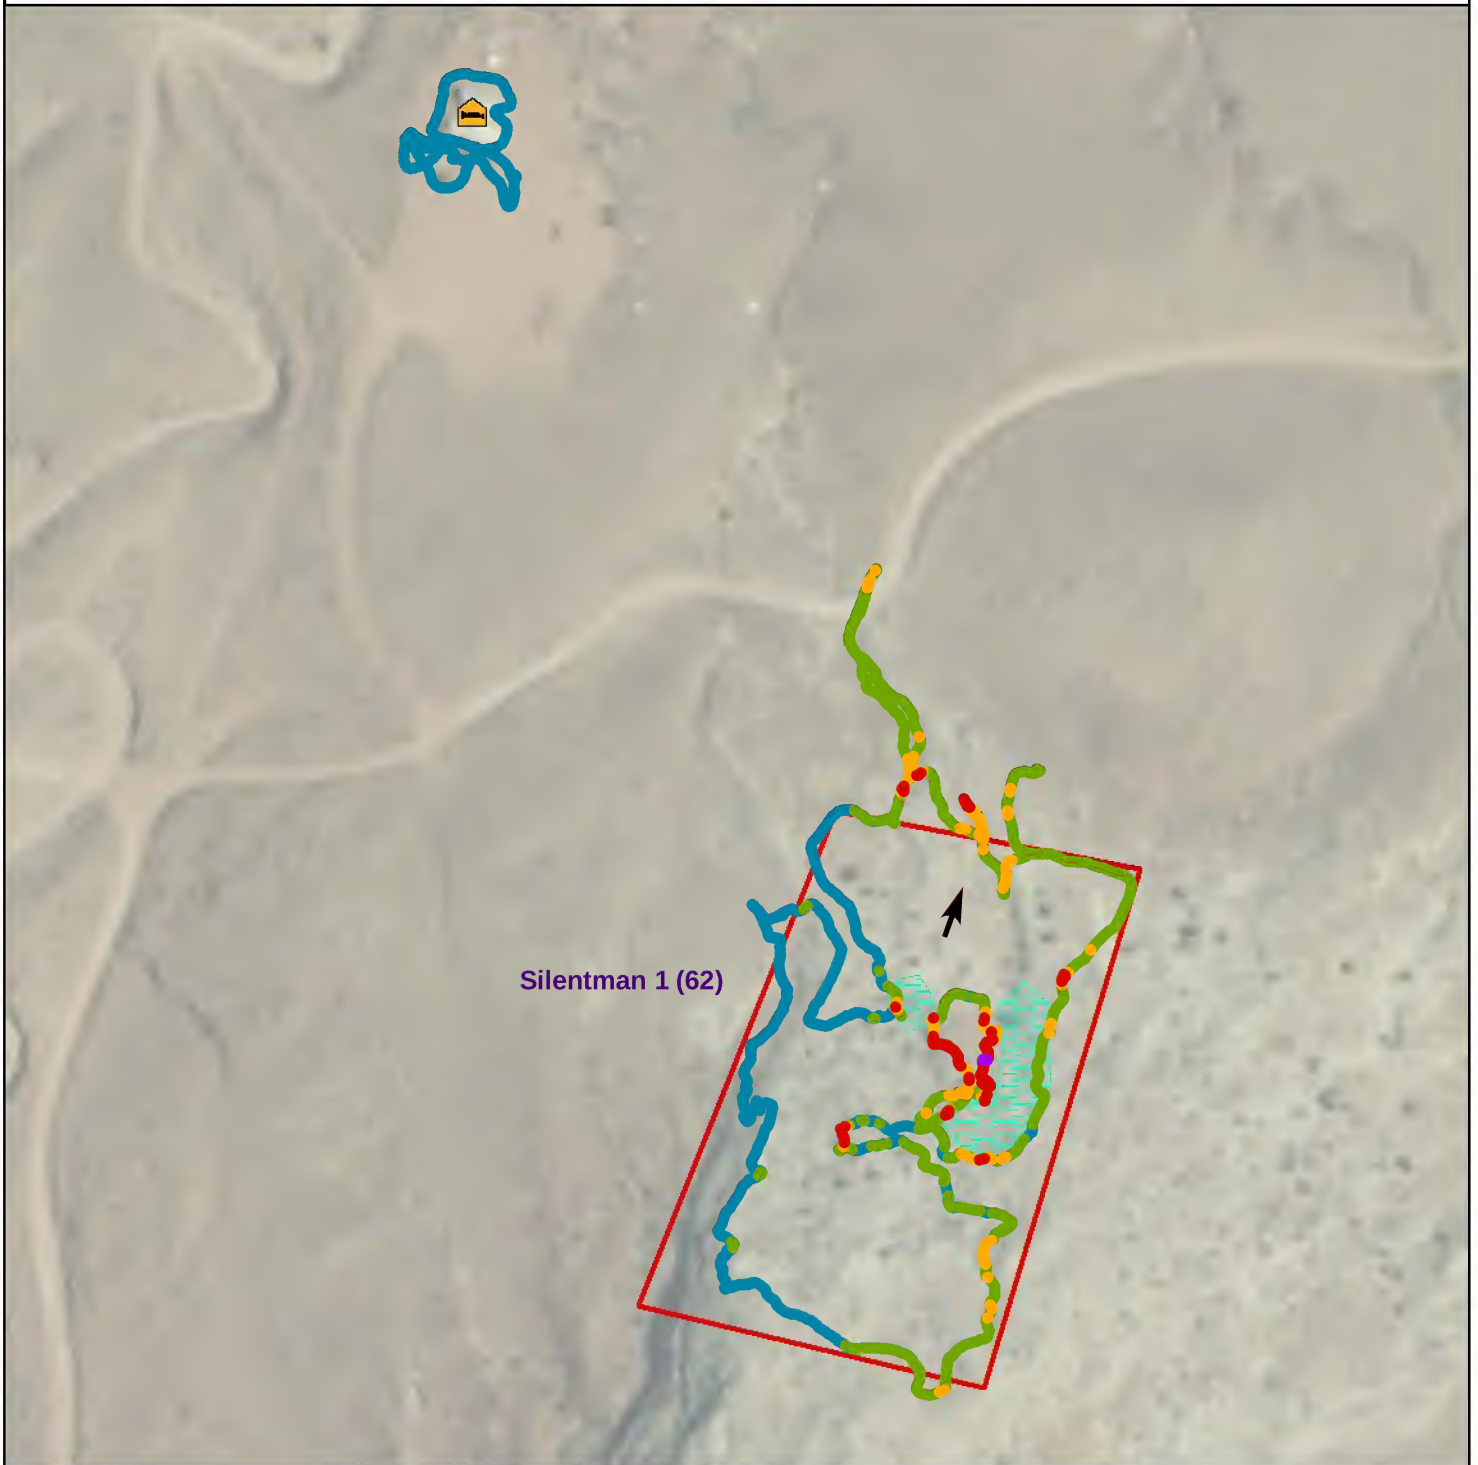
**Figure 2 - Gamma Radiation Measurements
Silentman 1 (62)
Teec Nos Pos Chapter, Navajo Nation**

Gamma survey conducted 06/2010
Measured as counts per minute (cpm)

Average background 11,042 cpm
